RIDEM Office of Water Resources
Monitoring and Assessment Program
Aquatic Invasive Species Monitoring Field Report

LAKE NAME: Upper Dam Pond

Waterbody ID: RI0006014L-04

Date Surveyed: August 28th, 2020

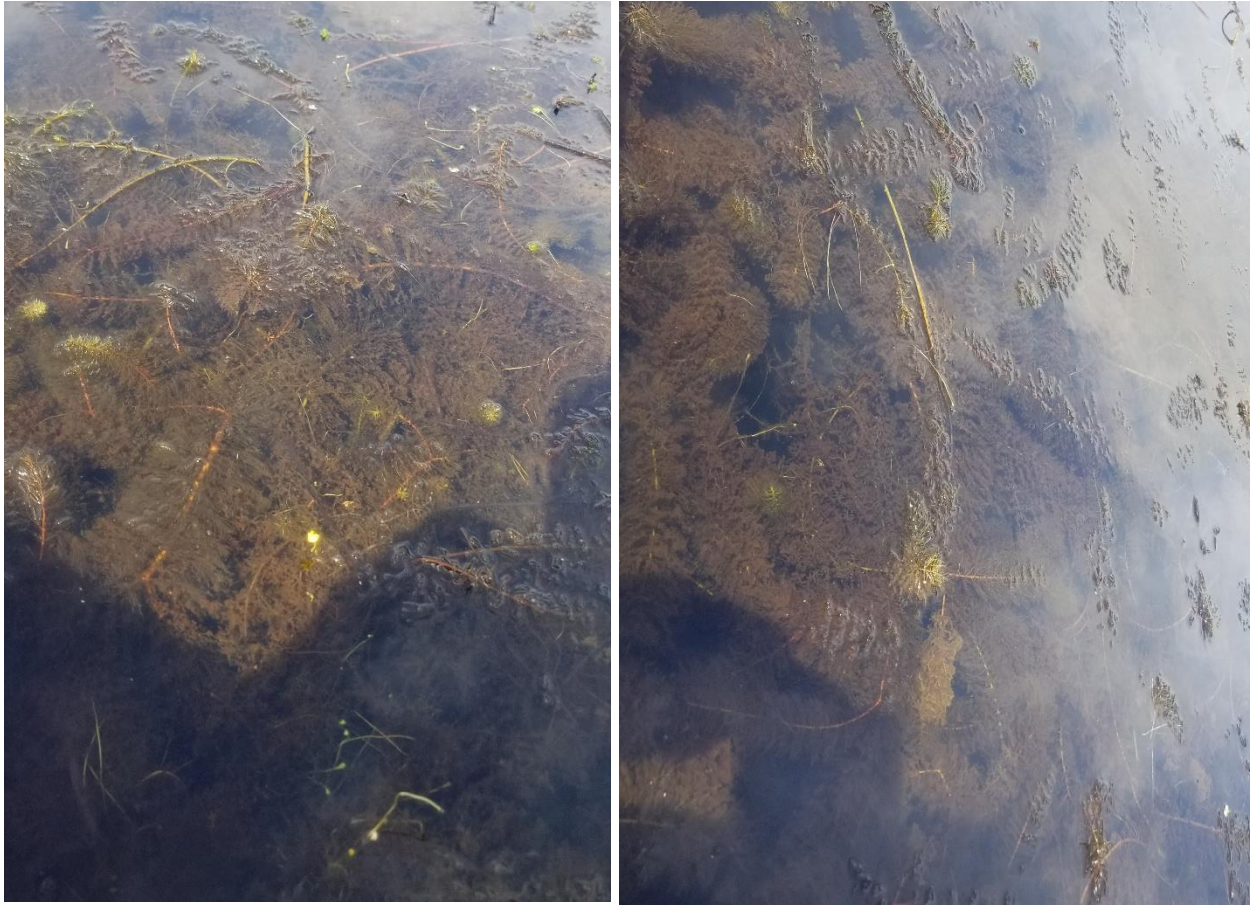
Figure 2: Thick layer of Variable milfoil submerged in upper Dam Pond.

The RI DEM team boated around the perimeter of Upper Dam Pond, identifying native and invasive plant species in the littoral zone (Figure 1). The RI DEM team had a hard time paddling the pond due to the thick density of submerged *Myriophyllum heterophyllum* (Variable milfoil) and thick density of floating *Brasenia sp.* (water shield) (Figure 2, Figure 3). Overall, the entire waterbody was difficult to paddle as the density of plants left very little open water to boat (Figure 4). The water was dark and 6 inches under the water surface there was a layer of cloudy green water. The cloudy water supports evidence that there may be an invasive carp population within the waterbody. The RI DEM team observed large fish jumping out of the water near their kayaks similar to carp behavior. The team also observed that the water levels were extremely low.

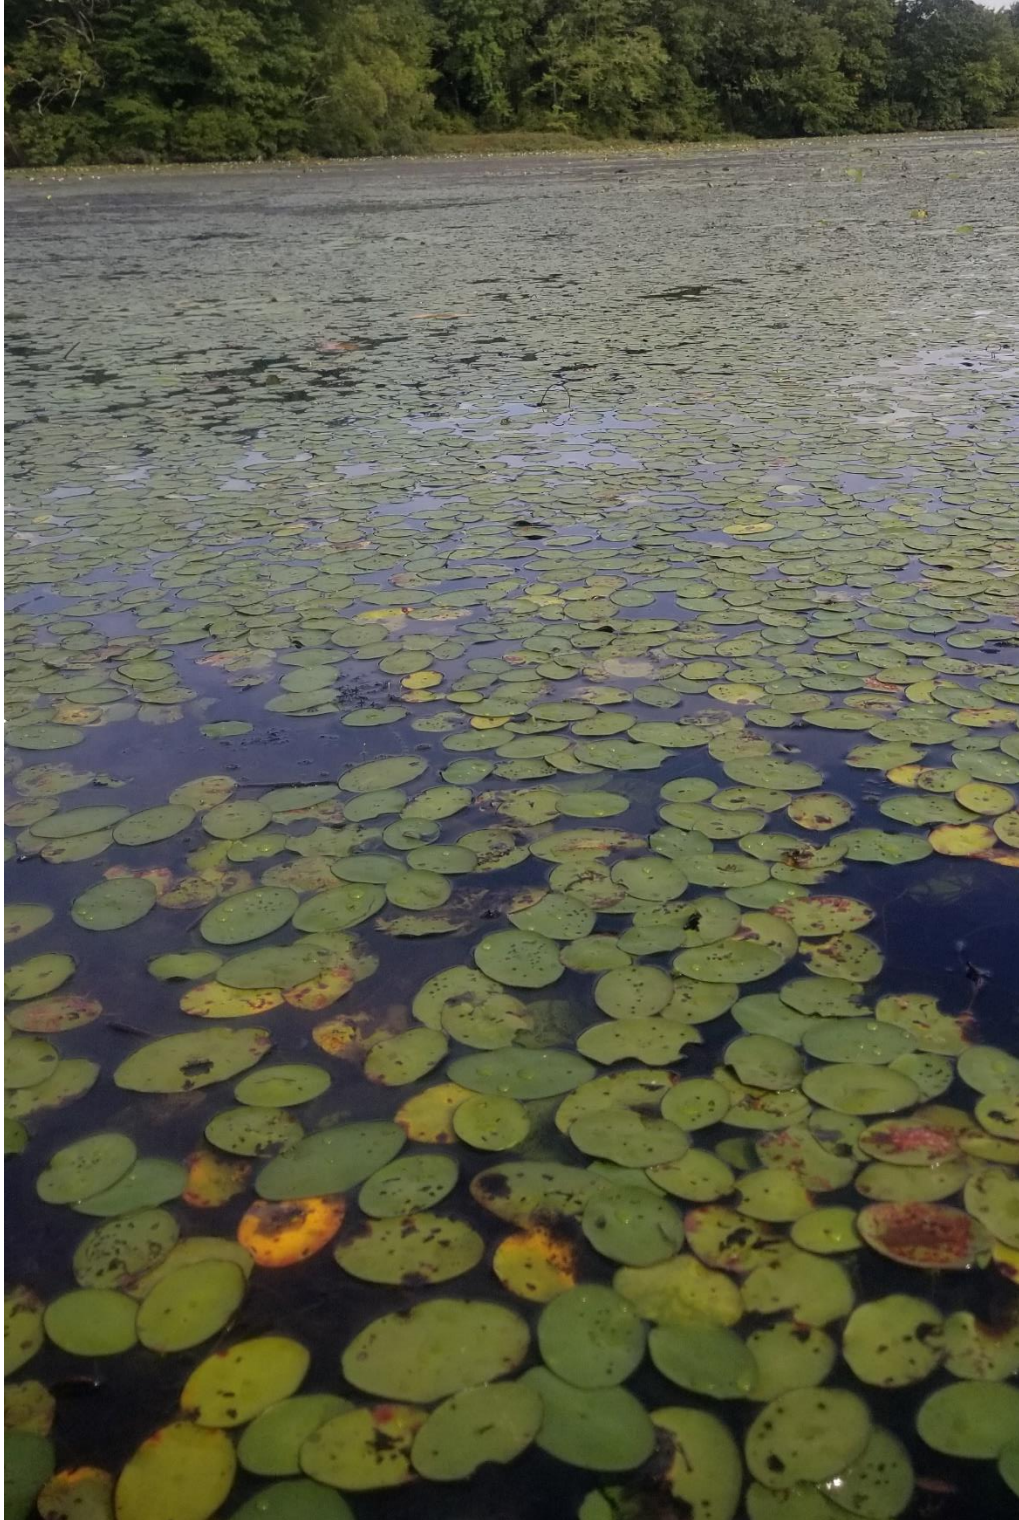
Figure 3. Thick layer of water shield covering Upper Dam Pond.

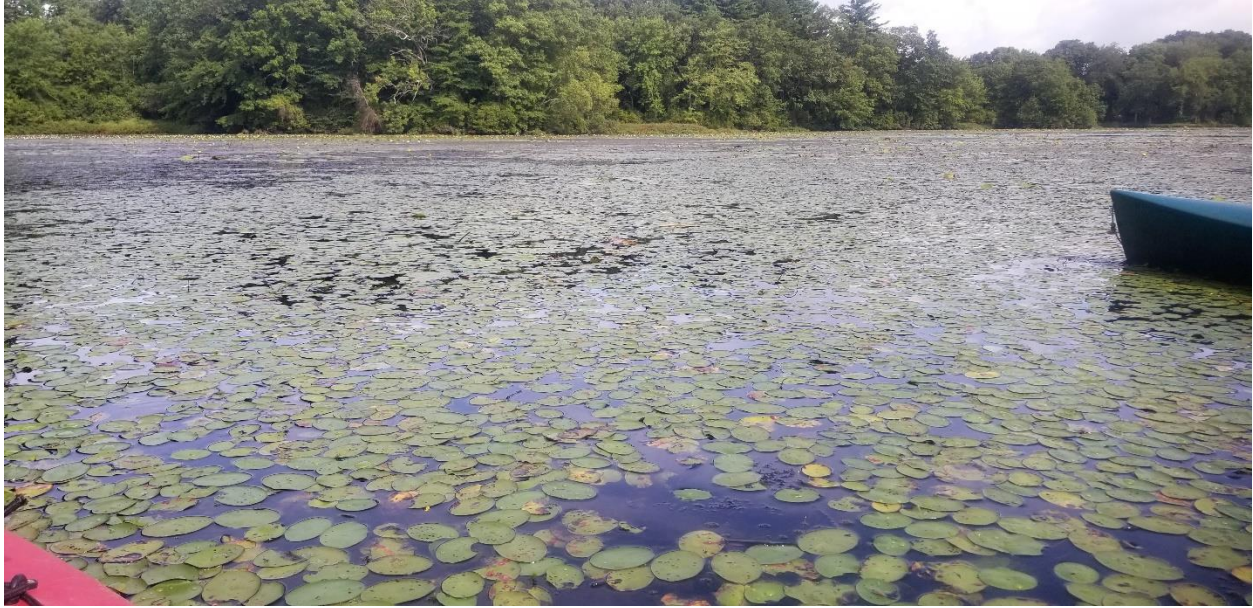
Figure 4. Surface coverage at Upper Dam Pond.
